Water Pollution Survey
Community of Lavigne
District of Nipissing

REPORT
ON A
WATER POLLUTION SURVEY
OF
THE COMMUNITY OF LAVIGNE
DISTRICT OF NIPISSING

DISTRICT ENGINEERS SECTION
SANITARY ENGINEERING BRANCH

1972

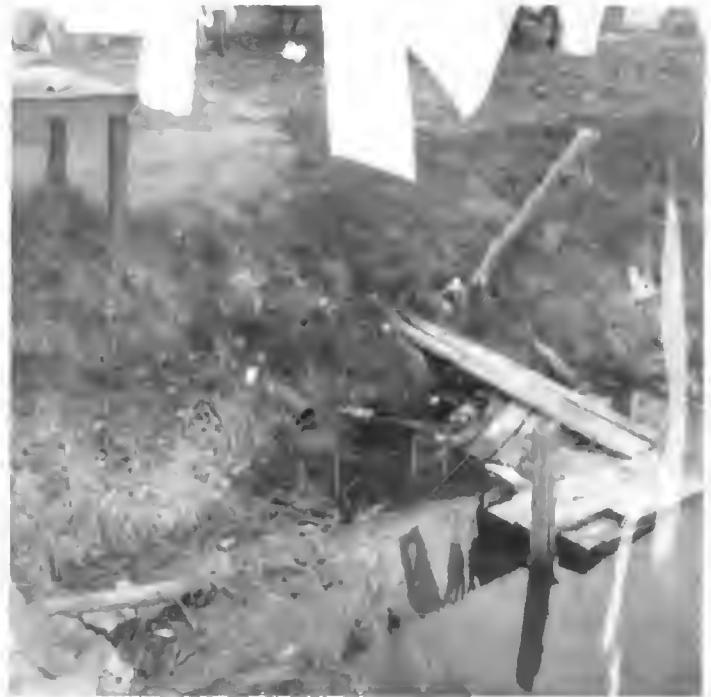
Photo #2

The obvious sources of pollution in the area of Laviqne Creek are septic tank discharge pipes from homes and cabins on the banks of the creek. A four-inch diameter cast iron pipe carries the hotel's septic tank effluent to this creek. This location is displayed in the appended photograph, No. 2. It was evident from viewing several homes along this creek bank that sewage was discharging directly to the water. In the area of Caron Road and the small creek, there are two obvious discharge pipes. It is apparent that septic tank - tile bed systems do not operate successfully with the existing clay overburden.

Looking northwest from private bridge over Lavigne Creek. The effluent pipe (4" C.I.) from the hotel is evident in the centre of the photo (sample point #12). Other sewage effluents are hidden immediately to the right of the photo.

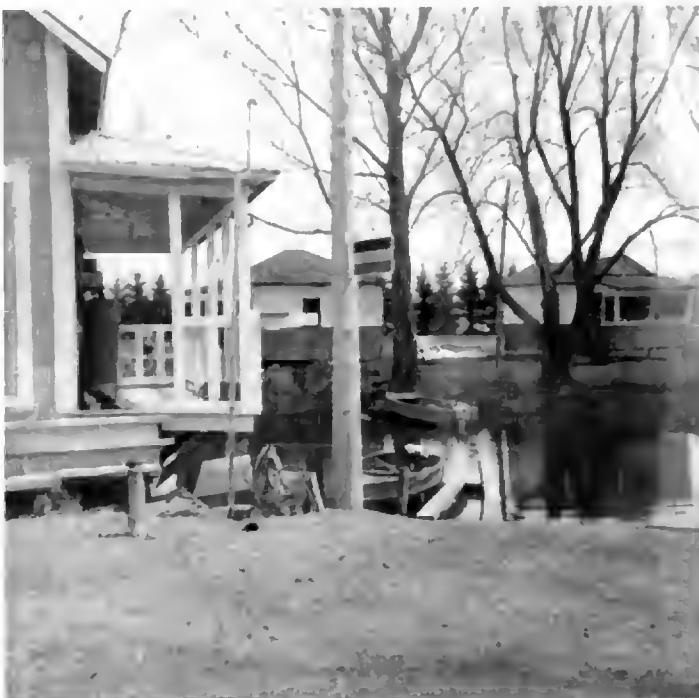
Photo #3

Looking east from Highway #64 across Lavigne Creek. Sewage from the building immediately to the left is openly directed to the creek with no apparent treatment. The left cottage on far bank has just received the repair and reconstruction of the septic tank effluent pipe to the creek. It is evident just below the cottage. This method of disposal is typical.

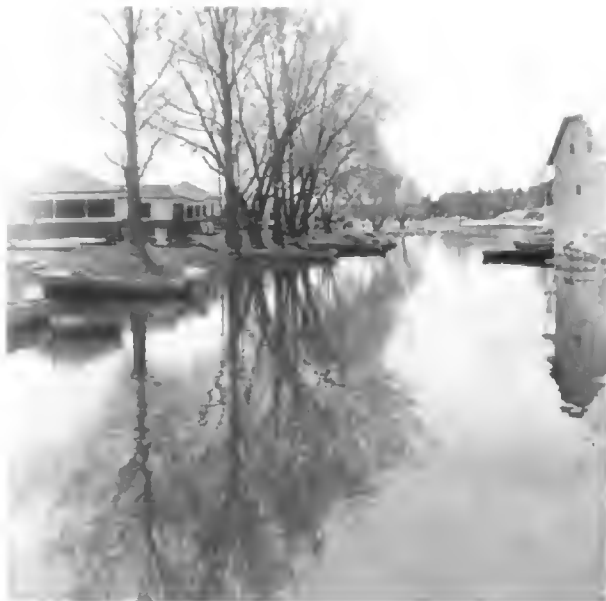
Photo #4

Looking south from private bridge towards Northwest Bay. This picture portrays the recreational activity in the area. None of the residences in this picture have adequate sewage disposal systems. The building on the right discharges sewage directly to the creek (Standard cast iron sewage pipe can be seen at the base of the building).

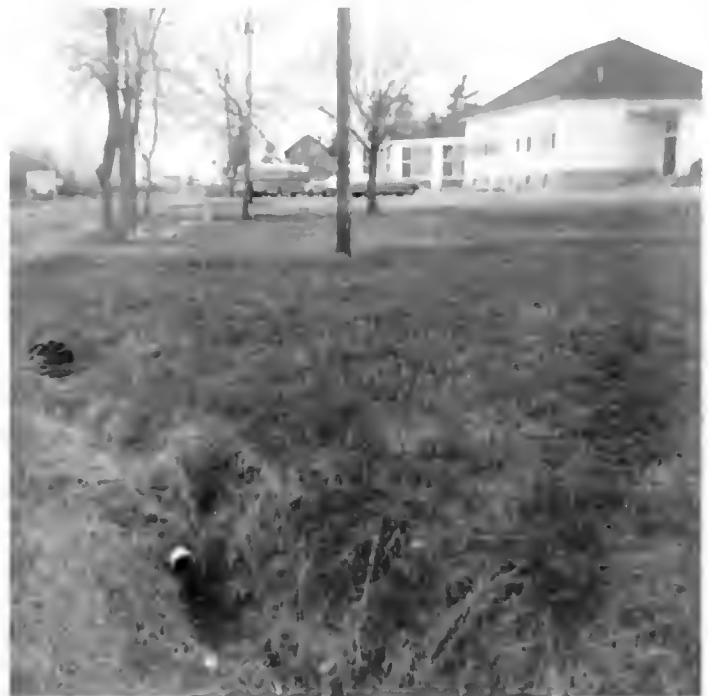
Photo #5

Samples which were collected later on May 16, 1972 indicated faecal coliforms to be similarly present in all cases. Sample 6 contained extremely high faecal coliform counts of 3 million per 100 ml. This sample was collected from the 4-inch diameter A. C. pipe located on the north ditch on Caron Road just south-east of the public school. It is evident that this is the effluent pipe from the existing school's tile bed system. High concentrations of faecal coliforms were also present at Sample Point 4, 8 and 10. These examination results indicate that sewage is present in the ditches on Caron Road and in the creek adjacent to the public school and in all the areas of Lavigne Creek. A sample of Lavigne Creek at the mouth was collected for chemical analyses. The results indicate that the BOD at this location was 30 ppm which far exceeds the generally accepted range for surface waters; the BOD of natural water is usually below 4 ppm. Phosphorus and nitrogen concentrations were found to be high at points 3 and 8. The generally accepted maximum limit for these parameters are 0.02 ppm and 0.5 ppm respectively for natural surface waters. These increased concentrations of nutrients indicate that sewage is gaining access to the watercourse.

Looking northwest from Caron Road at the public school. The 4" diameter asbestos concrete pipe (sample location #6) is evident at the lower left. This is reportedly septic tank effluent. The creek is immediately below the photo.

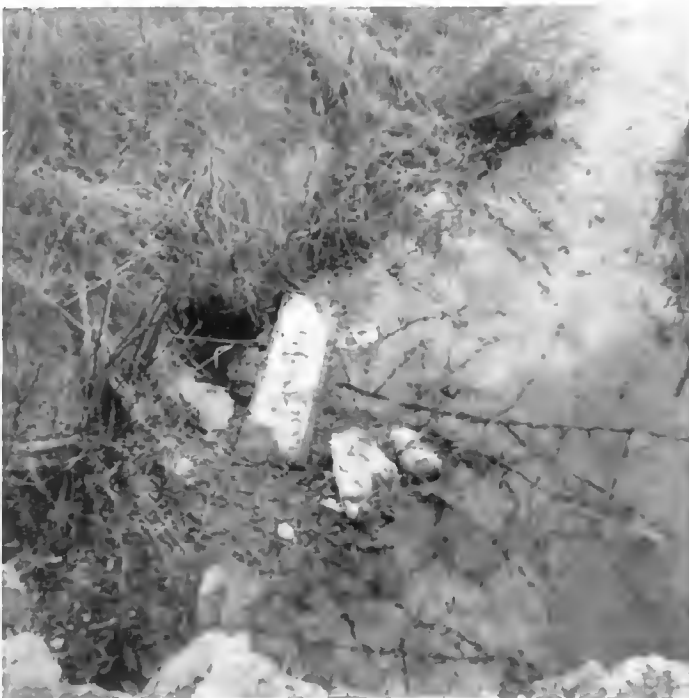
Photo #6

The chemical analyses of the discharge sample collected at the ditch south of Caron Road (7) indicates both a BOD (biochemical oxygen demand) and suspended solids concentration of 60 ppm which far exceeds this Ministry's objectives for surface waters. Analyses results of the effluent sample from the hotel indicate a similar condition. Bacteriological examination

Looking southeast from Caron Road at the Creek. Sewage effluent is evident from centre of photo (sample location #7) and runs south towards Northwest Bay.
